**Mount Allison  
Dendrochronology Lab**

Mad Lab Report 2006-29

A Dendroarcheological Analysis of Chapel Hill Church:  
Shag Harbour, Nova Scotia

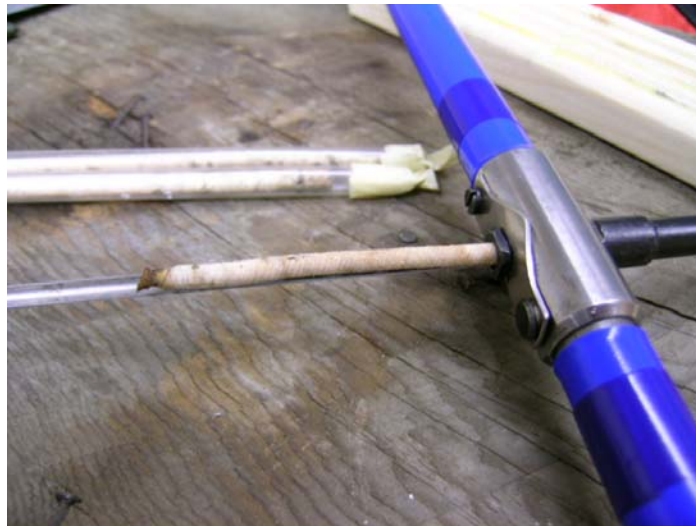
**Figure 2:** Sample extracted with an increment borer.

Twenty-five samples were taken from a total of twenty-four beams using an increment borer (see Appendix A). The diameter of each sample is 4.3 mm, approximately the size of a pencil (Figures 2, 3). The sampling process has no negative effects on the structural integrity of the building. All of the beams sampled are located in the attic of the church, where they have not been altered since the initial construction of the church. Beams were selected for sampling according to their integrity (the absence of rot) and the presence of bark (indicating the last tree-ring has not been removed in the construction of the church).

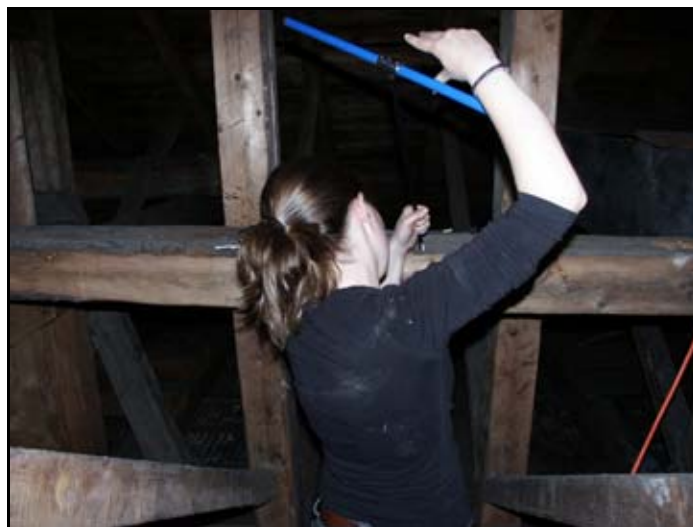
**Figure 3:** Collecting samples at Chapel Hill Church

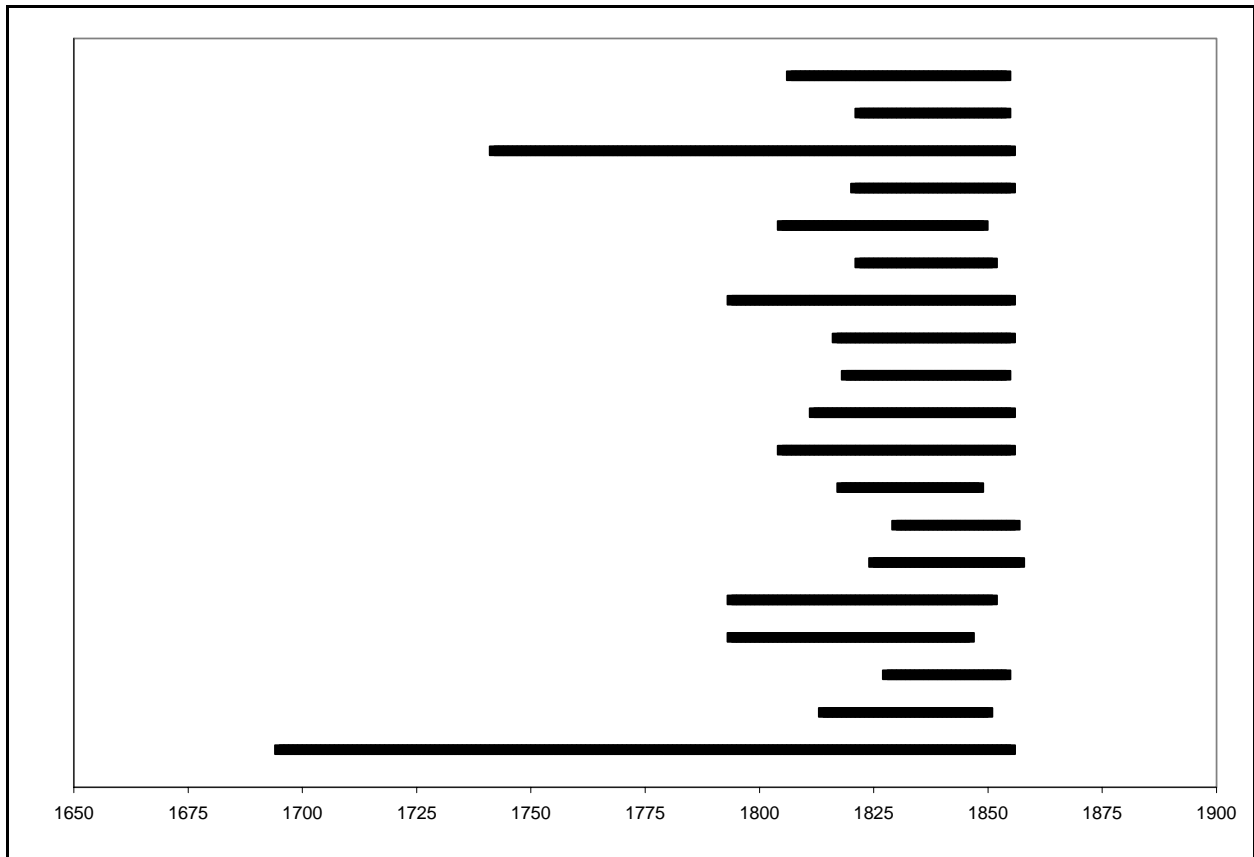
**Figure 4:** Life-spans of trees within beams of Chapel Hill Church.

Based on an analysis using COFECHA, it was determined that the last year of growth of the trees within the church beams was 1855 (Figure 4, Table 1). This suggests that the trees used in the construction of the church were cut down with the last growing year being 1855, approximately a year before the building was constructed. Based on construction and logistical schedules of the time, it is reasonable to believe that the trees were felled in the fall/winter of the year before construction began. This fact confirms the historical records stating that Chapel Hill Church was constructed in 1856.

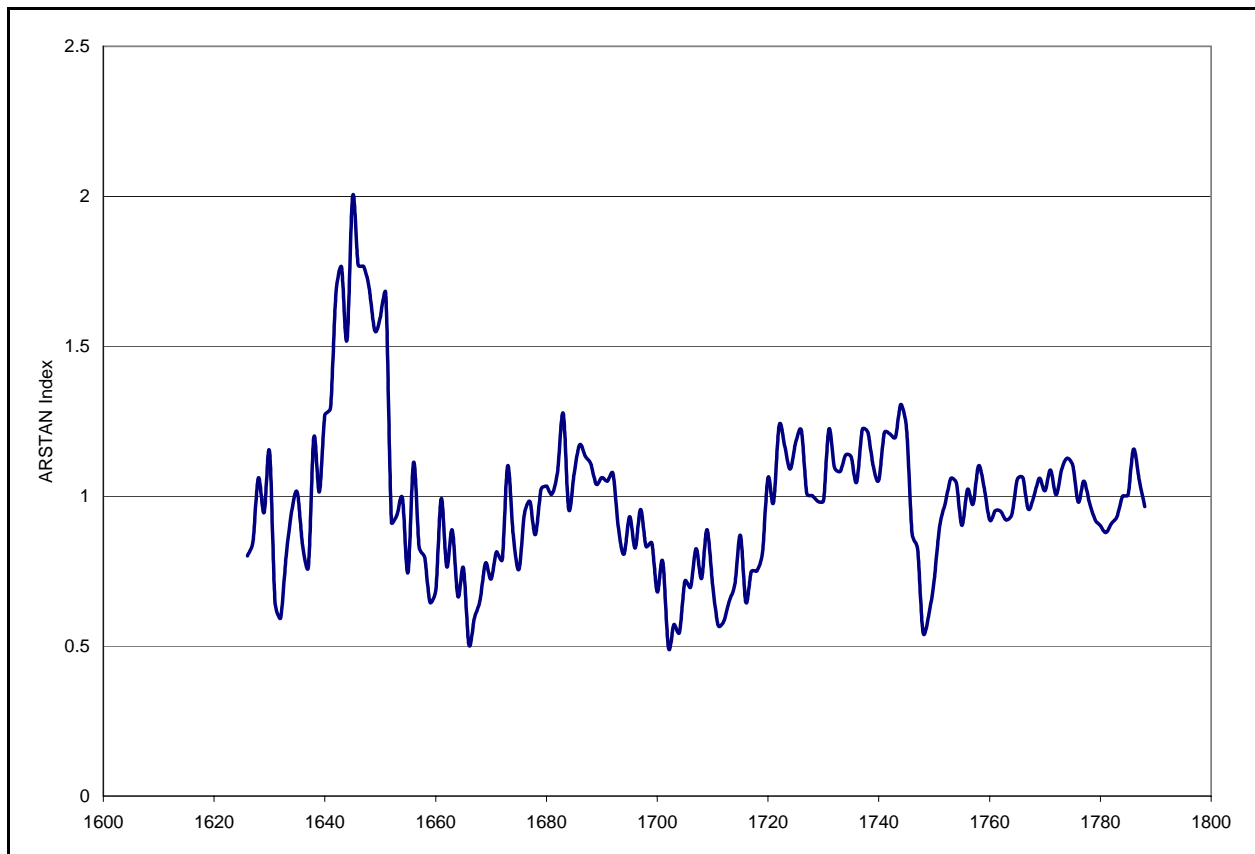
**Figure 5:** Floating chronology for red spruce in Chapel Hill Church.

Once the cut years of the trees were determined, it was possible to create a floating chronology for the “stand” (Figure 5). This shows the average growth patterns for all of the red spruce sampled within the beams of the church.

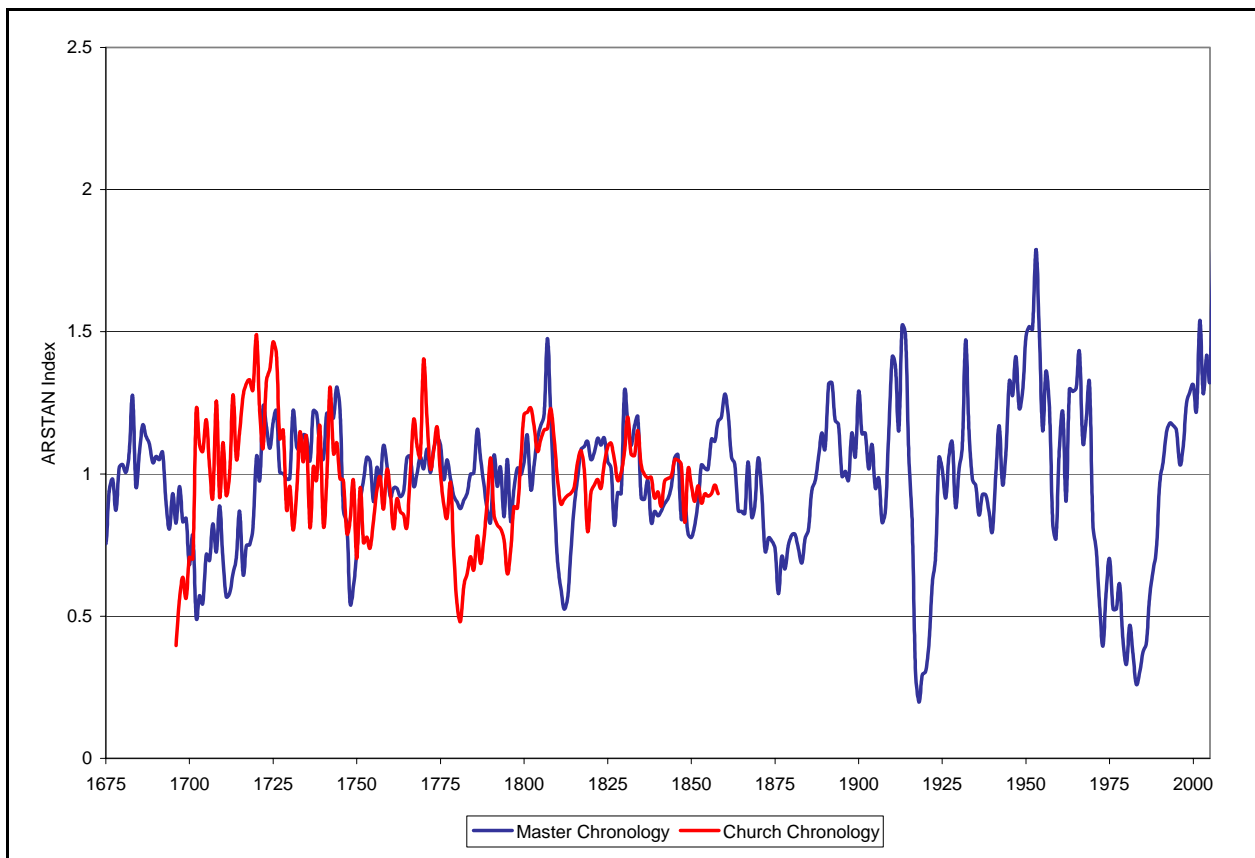
**Figure 6:** Overlap of the master and church chronologies shows similar growth patterns.

The beams from this church effectively contribute to the two of the project’s objectives which are to increase red spruce sample depth in Nova Scotia and to create a master chronology specific to southwestern Nova Scotia (Figure 6). All beams crossdate into the live chronology with a significance ranging from 0.085-0.528 (90% confidence of significance at 0.21). Out of the fifteen samples, twelve achieve 90% significance or higher, with correlations to the live chronology above 0.21. The reason that the significance levels are not higher than 90% is likely that the live chronology is based predominately on red spruce trees growing in New Brunswick. The distance between the habitats of the live chronology and the stand that made up the church chronology may be the reason for this discrepancy.

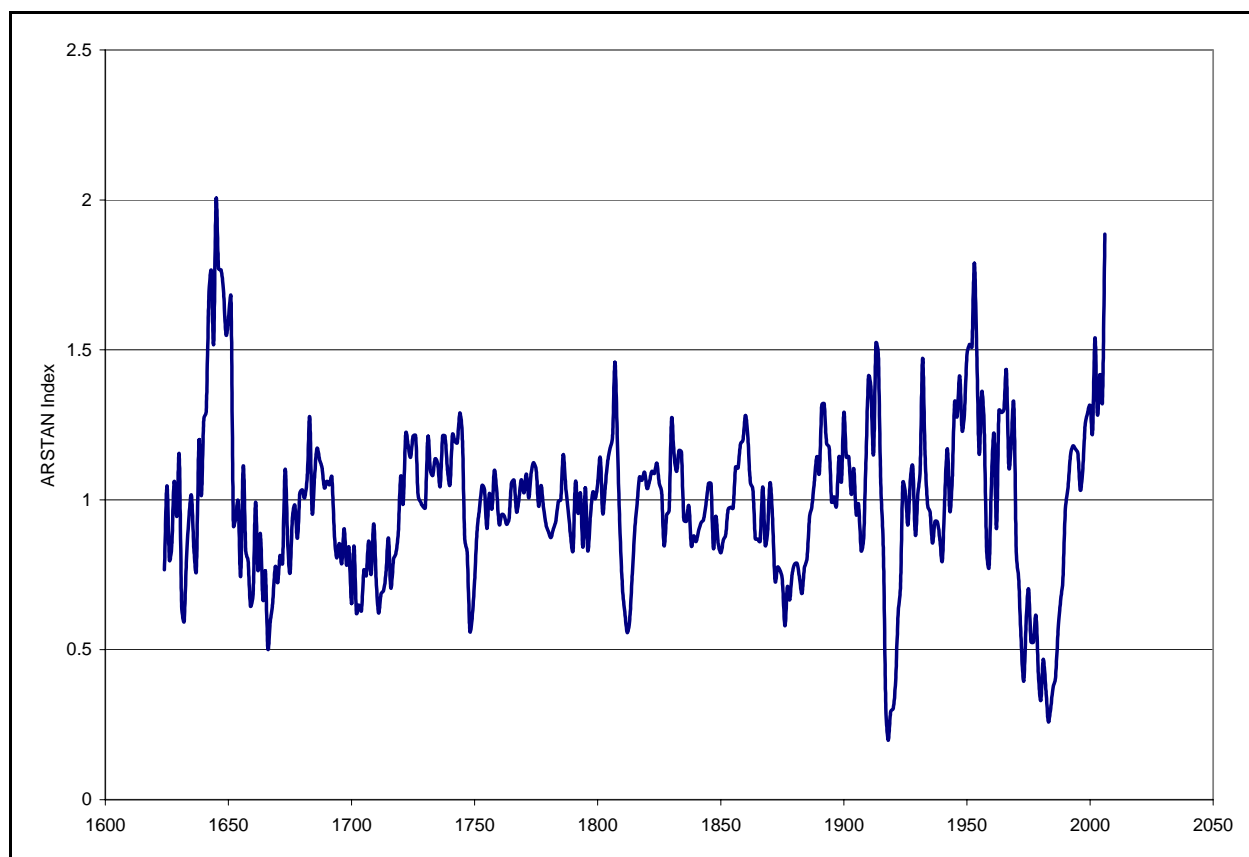
**Figure 7:** Combined master chronology for red spruce in New Brunswick and Nova Scotia.

By combining the master and church chronologies, it was possible to develop a master chronology for red spruce in New Brunswick and Nova Scotia (Figure 7). The overall correlation of this chronology is 0.486, which is much higher than the 0.3281 required for 99% confidence of significance.

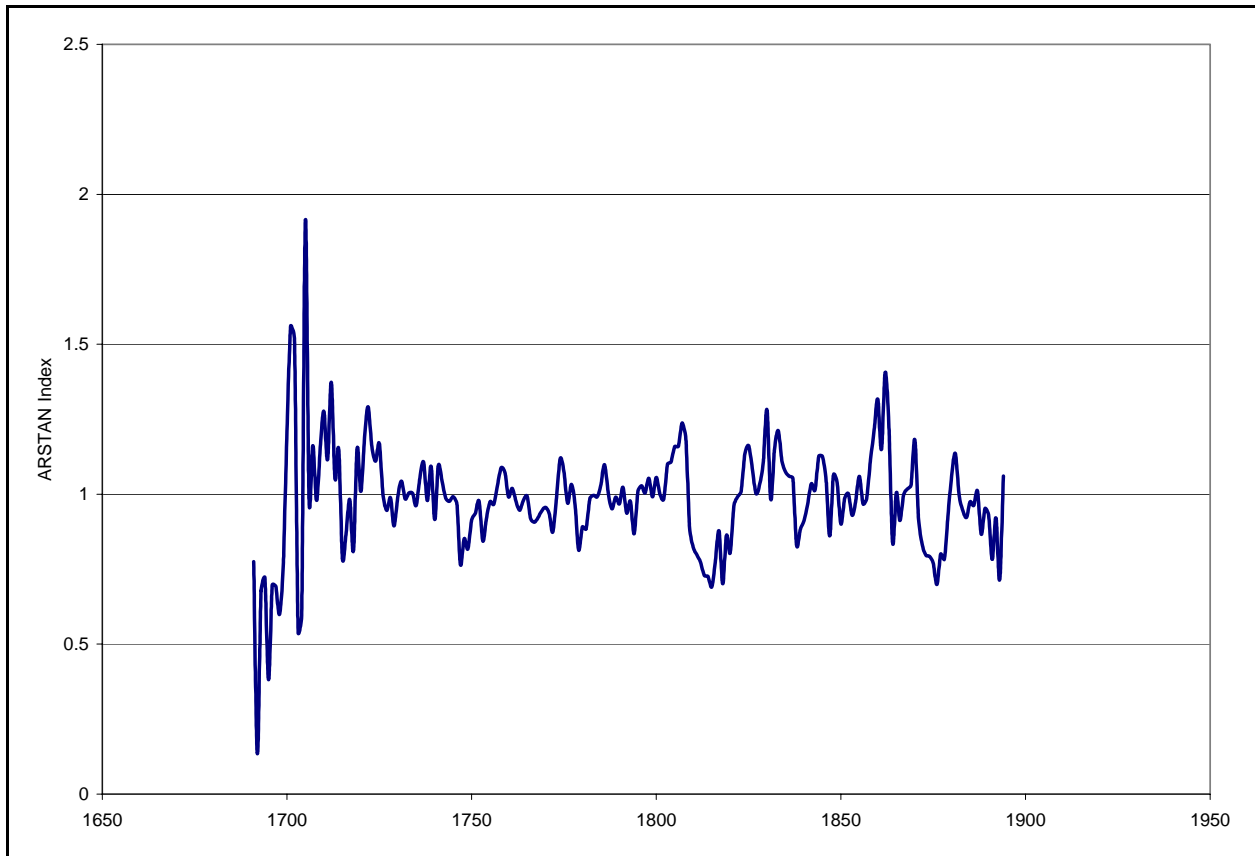
**Figure 8:** Master chronology for red spruce in southwestern Nova Scotia.

From the church chronology constructed from Chapel Hill Church as well as the chronologies constructed from the other churches sampled in southwestern Nova Scotia, it was possible to make a master chronology specific to the region (Figure 8).
