Dendrochronological Analysis of 98 Charlotte Street, Sydney, NS

Amanda B. Young and Colin P. Laroque
MAD Lab Report 2010-05
Mount Allison Dendrochronology Laboratory,
Department of Geography and Environment,
Mount Allison University

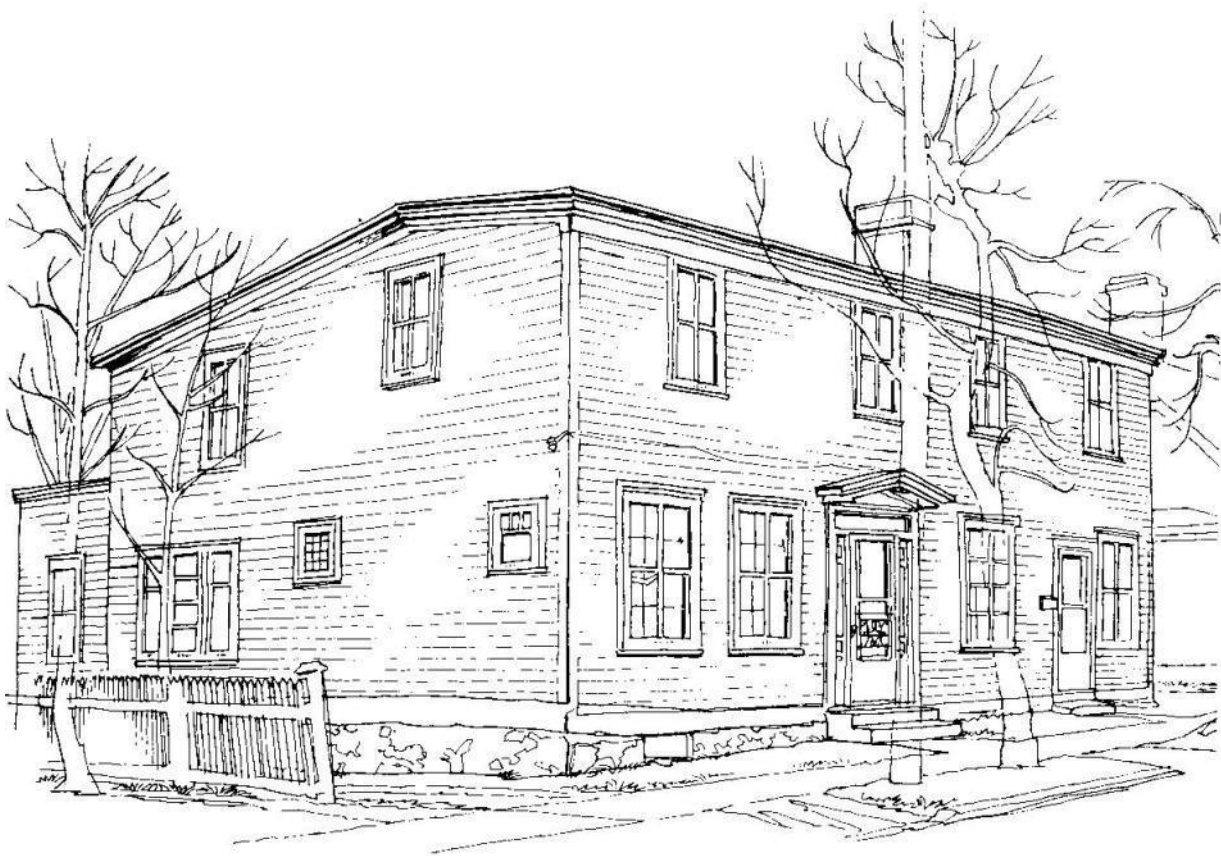
Figure 1. A line drawing of 98 Charlotte Street, provided by Peyton Chisholm.

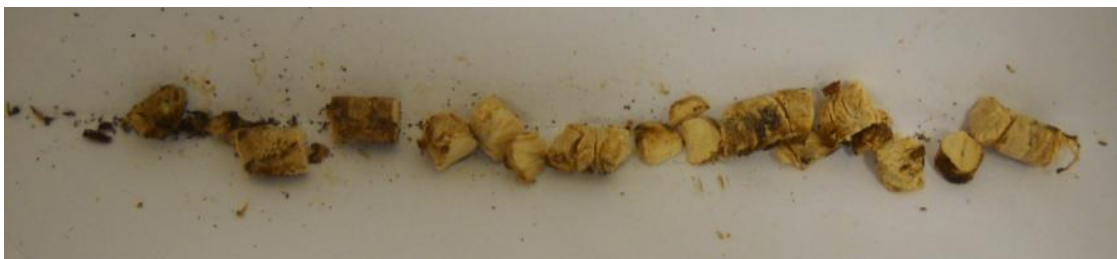
Figure 2. Example of a core extracted from 98 Charlotte Street cores in this condition are not able to be used for any dendrochronological analysis.

Fourteen cores were collected by the ADI Limited team on February 19th. Due to extensive dry rot and inexperience at coring, all of the cores were broken up and in too many pieces to be used in any type of dendrochronological analysis (Figure 2). Adam Cashin of ADI Limited was able to collect six cross-sections from the structure. Three are main floor beams, two are ends of floor boards and the last a post from a section of the floor cut during renovations (Appendix I).

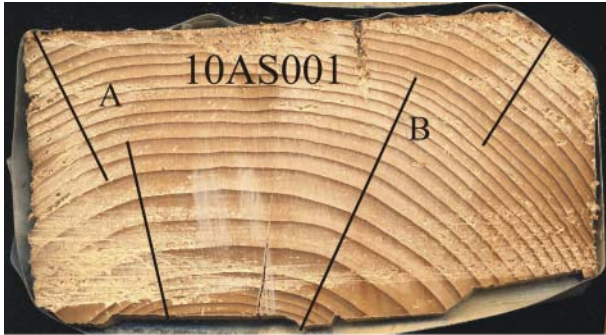
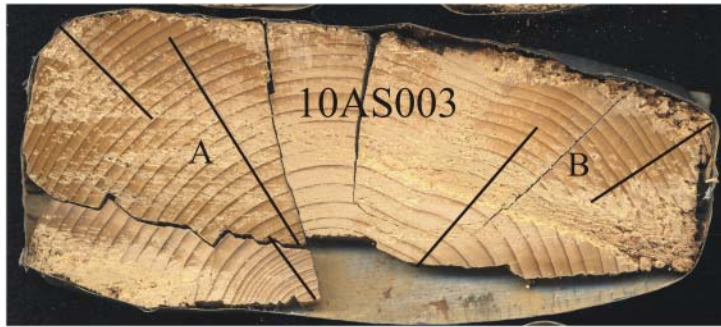
Appendix II. Samples taken from 98 Charlotte St. with measured paths identified.

Samples were relabeled using the MAD Lab site code 10AS000. Each sample was labeled with an individual item code and taped together to maintain soundness. Samples were then sanded with progressively finer sand paper (80-400 grit) to bring out the cellular structures and annual rings of the wood. The species of each sample was determined and then recorded. Rings were counted and measured from the bark to the pith (middle) of each core sample using a Velmex measuring system with an accuracy of 0.001mm along three paths (Appendix II).
