**A Dendroarcheological Analysis of the Doucet-Hennessy House,
Bathurst, New Brunswick**

Amanda B. Young, Ben E. Phillips and Colin P. Laroque
MAD Lab Report 2010-01
Mount Allison Dendrochronology Laboratory,
Department of Geography and Environment,
Mount Allison University

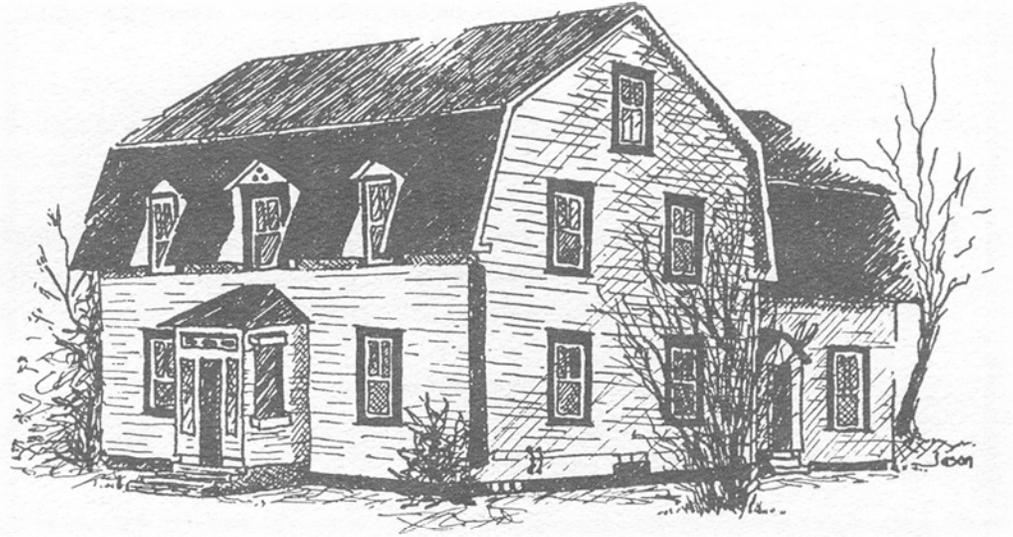
The current layout of the Doucet-Hennessy house is a 'T' shape; it has two stories with an attic and no brick chimneys (Figure 2). The basement of the building has remnants of two brick chimneys, one on each side of the front section of the house that have since been taken apart. These two chimneys are remembered by members of the Hennessy Family.

Figure 2. Doucet-Hennessy House, Bathurst, NB. (Bathurst Heritage Trust Commission)

The standing structure, with its symmetrical layout including the centrally placed chimneys, central hallway and staircase, and symmetrical rooms two deep, is more reminiscent of the Georgian style architecture used by English colonies. The chimneys were removed, most likely when the original pitched roof was replaced by the mansard style roof (second roof), as there is no evidence of chimneys ever protruding through the second storey. One of the disassembled chimneys had two beams used as supports that dated to the 1830's, suggesting that these chimneys had been removed long ago, using recycled wood as replacement supports.

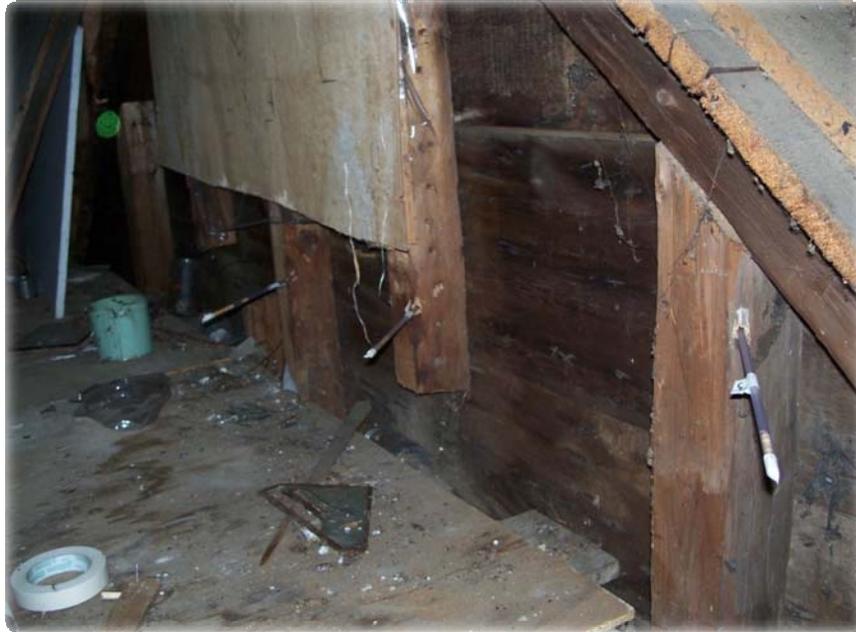
The roof appears to have been constructed in three phases (Figure 3). The gable end of the original pitched roof can be seen with the wall beams and a covered attic window (Figure 4). The second roof is of mansard style and can be seen arching over the original gable from the joint of the “T” construction of the house, which is roofed over by the third roof (Figure 5).

Figure 4. Samples 09ARS003, 4, and 5 taken from the south side of the attic. The image also illustrates the remnant gable end of the original roof with the sampled exterior wall beams (centre), a covered attic window (top left) and the original roof line (top right).
